# Geotechnical aspects of the Carsington Dam failure

A.W.SKEMPTON, Professor, Department of Civil Engineering, Imperial College, London, UK

Carsington Dam is an earth-fill embankment with a length of 1200 m and a maximum intended height of 37 m above foundation level. It is situated in Derbyshire, in the Midlands of England. On Friday 1 June 1984 the dam was within about 1 m of its final height. No fill was placed during the weekend, a period of heavy rainfall. Early in the morning of Monday 4 June a slip started in the upstream bank over a length of 190 m and by Thursday 7 June it extended along a length of nearly 500 m, with a maximum horizontal displacement of 15 m.

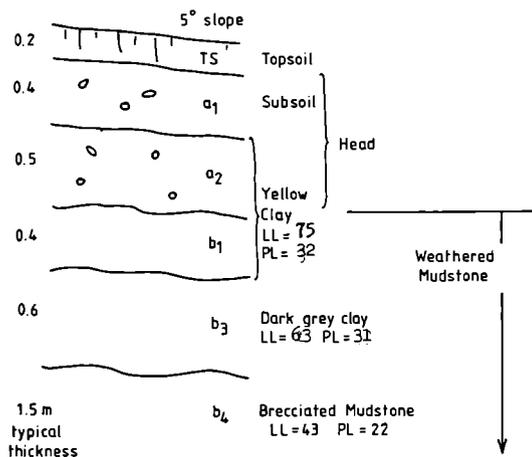
Fig. 2 Section in natural ground

Test pits in the lower valley slopes just upstream of the dam reveal a typical section as shown in Fig. 2. Head, containing occasional 'foreign' pebbles derived from the upland glacial deposits, averages about 1.2 m in thickness. It lies over, and (apart from the pebbles) is practically indistinguishable from, mottled yellow, brown and grey clay forming the top of the in-situ weathered mudstone. For geotechnical purposes Head beneath the subsoil ( $a_2$ ) and this upper layer of weathered mudstone ( $b_1$ ) are grouped together under the name 'Yellow Clay'.

Near the junction of  $a_2$  and  $b_1$  there are shear surfaces, formed by downslope movement of Head in the last glacial period. The shears are smooth, gently undulating surfaces, often gleyed and typically several metres in extent. On average they occupy rather more than 50 percent of the total length of 62 m examined in test pits outside the dam.

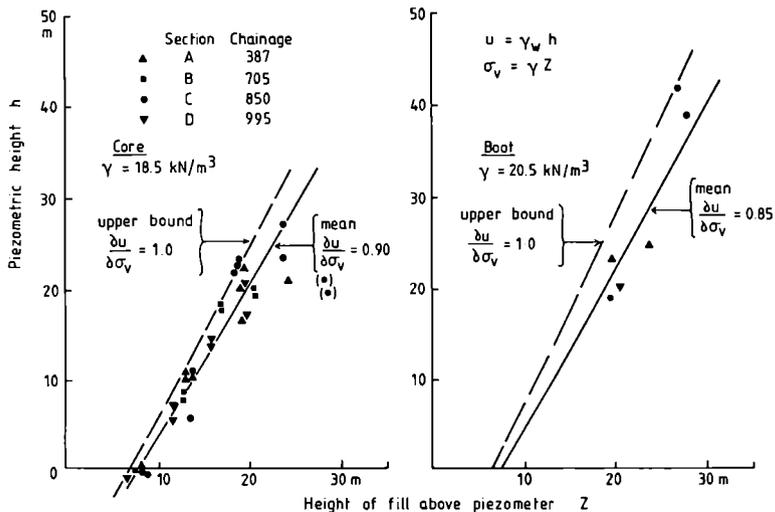
Fig. 3 Piezometer observations, 21 May 1984

Systematic piezometer observations throughout construction show little if any excess pore pressures in the foundation strata or in Zone II fill, and only small pore pressures in Zone I. The relationships between pore pressure and height of fill above piezometer level in the core and boat are plotted in Fig. 3, the data being derived from the last complete set of observations at four instrumented sections two weeks before failure. The measured values incorporate the effect of a small amount of pore pressure dissipation, principally in the boat, during the winter shut-down periods.

The relationship between pore pressure and vertical overburden pressure, derived from field observations, is shown in Fig. 3. The average coefficient of consolidation is  $c_v = 2 \text{ m}^2/\text{year}$ .

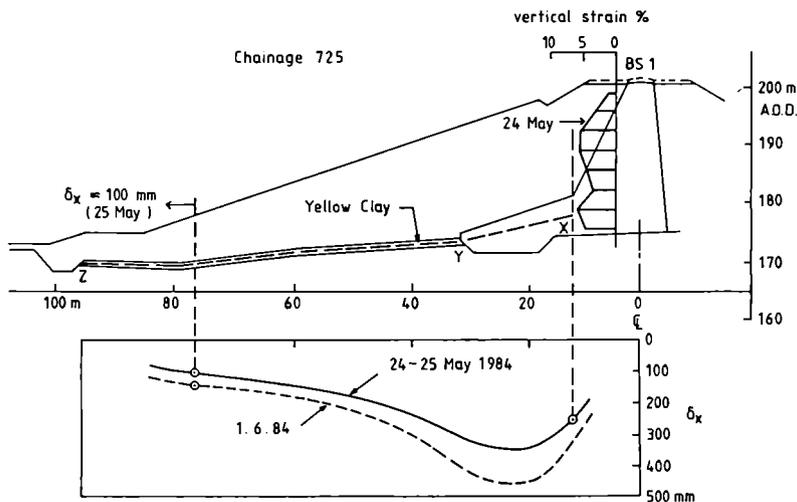
Fig. 4 Horizontal movements on line XZ and vertical strain in core

From 18 August 1983 observations were made of horizontal displacements of the upstream face of the dam at survey points or 'pegs' in the position shown in Fig. 4. Measured displacements on 25 May 1984 are given in Table 1 together with approximate total displacements estimated by backward extrapolation to the start of construction. These movements clearly reflect the height of fill, see Fig. 5, and by interpolation the total displacement on 25 May at Ch. 725 is about 100 mm.

A finite element analysis of this section by Dr David Potts of Imperial College provides a pattern of the distribution of displacements as sketched in Fig. 4.

By 1 June, about 0.5 m of fill having been placed in the preceding week, the 'peg' displacement increased from approximately 100 to 140 mm. The other displacements in the section probably increased more or less in the same proportion giving the pattern, immediately before failure, indicated by the dotted line in Fig. 4. The corresponding average vertical strain in the core is about 6.5 percent.

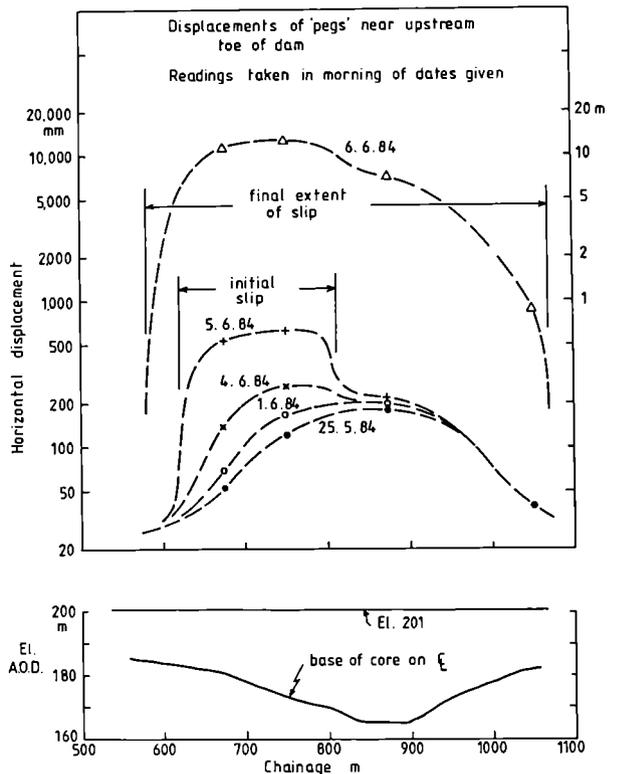
Fig. 5 Propagation of slip movements

Between 9.30 a.m. on Monday 4 June and the same time on Tuesday 5 June the 'pegs' at Ch. 675 and 750 moved a further 380 and 360 mm respectively, so in this 24 hour period slip had been taking place, on average, at 15 mm/hour. In this period creep movements of 9 mm/day started at Ch. 875. Total movements were now approximately 520 mm at Ch. 675, 620 mm at Ch. 750 and 210 mm at Ch. 875. These movements vividly demonstrate the initial slip: see Fig. 5.

During Tuesday morning slip accelerated to 100 mm/hour and the failure propagated southwards; as measured at Ch. 875 slip was now occurring there at 11 mm/hour. During the afternoon rates

increased rapidly. By 6.30 p.m. the initial slip had moved 2.5 m and the subsequent slip (at Ch. 875) rather more than 0.5 m.

By Wednesday morning (6.6.84) the slip reached still further south; even at Ch. 1050 a movement of 0.9 m was recorded, and in the central portions the displacements were now between 7 and 12 m (Fig. 5). Meanwhile an emergency berm was being built on the upstream toe. The combined effect of the berm and the large slump at the crest eventually brought motion to a halt by Thursday morning. The slip at that time extended from Ch. 580 to 1070, a total length of nearly 500 m.

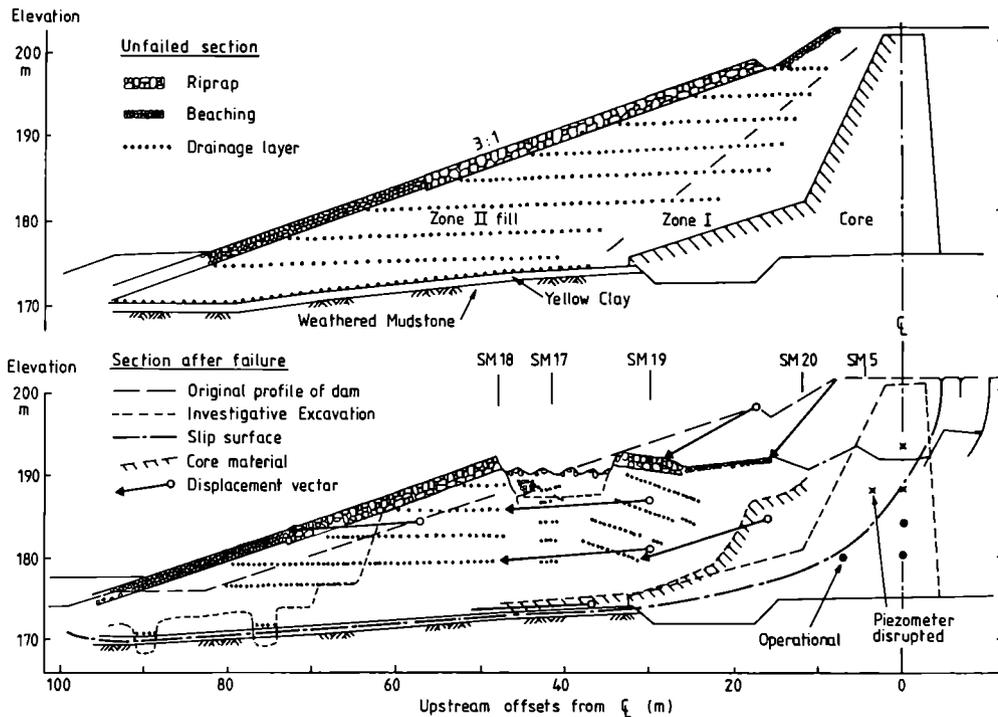
Fig. 6 Investigative section at chainage 725

Borings and a large excavation with two pits taken down through the foundations enable the section shown in Fig. 6 to be drawn at Ch. 725, near the centre of the initial slip where maximum displacement occurred. The principal features are: a near-vertical slump and back scarp 10 m deep at the crest, backward rotation of a block upstream of the core, resulting in a deep-seated thrust and a graben in the tension zone above, and a sub-horizontal translation of the toe block of about 15 m. The slip surface passes down through the core and foot and through the Yellow Clay, finally thrusting up over the small rock-fill toe.

A similar pattern was found in the flood plain section at Ch. 825 but here, in the absence of the Yellow Clay, the slip surface passes through the Zone II fill about 1 m above its base.

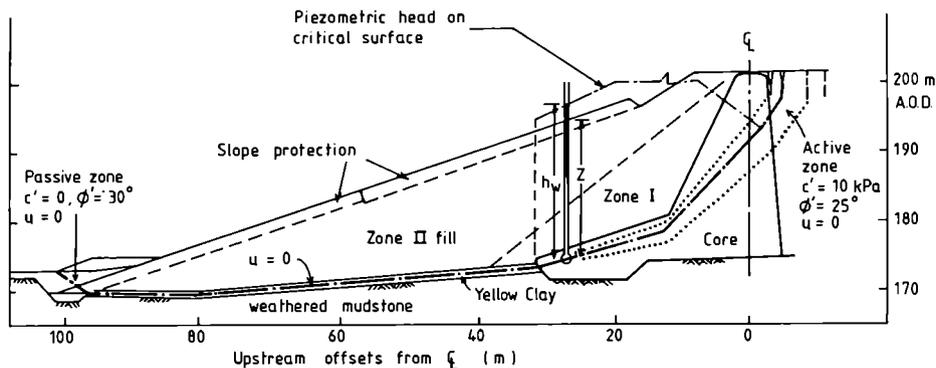
Fig. 15 Chainage 725 Multiple wedge analysis

The section at Ch. 725 is selected as representing the initial failure, Fig. 15. Factor of safety is defined in the usual manner as

The critical slip surface, leading to a minimum factor of safety, is found by trial and error within the bounds shown in Fig. 15. It corresponds rather closely to the best estimate of the actual slip surface as sketched in Fig. 6.

Factors of safety for various strength parameters are given in Table 3. Results are quoted to the nearest 5 percent, for the sake of comparison, but in absolute terms an accuracy better than  $\pm 10$  percent cannot be expected in stability analysis.

- (1) Intact peak strengths lead to a 40 percent overestimate of stability or, in other words, to obtain the correct result a reduction of  $(1 - \frac{1}{1.4}) = 29$  percent is required.

(ii) When the effect of pre-existing shears is taken into account the maximum available strengths lead to a 15 percent overestimate of stability. Thus the pre-existing shears account for a reduction in factor of safety of  $(1 - \frac{1.15}{1.4}) = 18$  percent.

(iii) The further reduction of  $(1 - \frac{1}{1.15}) = 13$  percent required to produce a factor of safety of 1.0 can be attributed to progressive failure, resulting from large strains in the core and Yellow Clay prior to the slip.
