# Geotechnical aspects of the Carsington Dam failure

A.W.SKEMPTON, Professor, Department of Civil Engineering, Imperial College, London, UK

Carsington Dam is an earth-fill embankment with a length of 1200 m and a maximum intended height of 37 m above foundation level. It is situated in Derbyshire, in the Midlands of England. On Friday 1 June 1984 the dam was within about 1 m of its final height. No fill was placed during the weekend, a period of heavy rainfall. Early in the morning of Monday 4 June a slip started in the upstream bank over a length of 190 m and by Thursday 7 June it extended along a length of nearly 500 m, with a maximum horizontal displacement of 15 m.

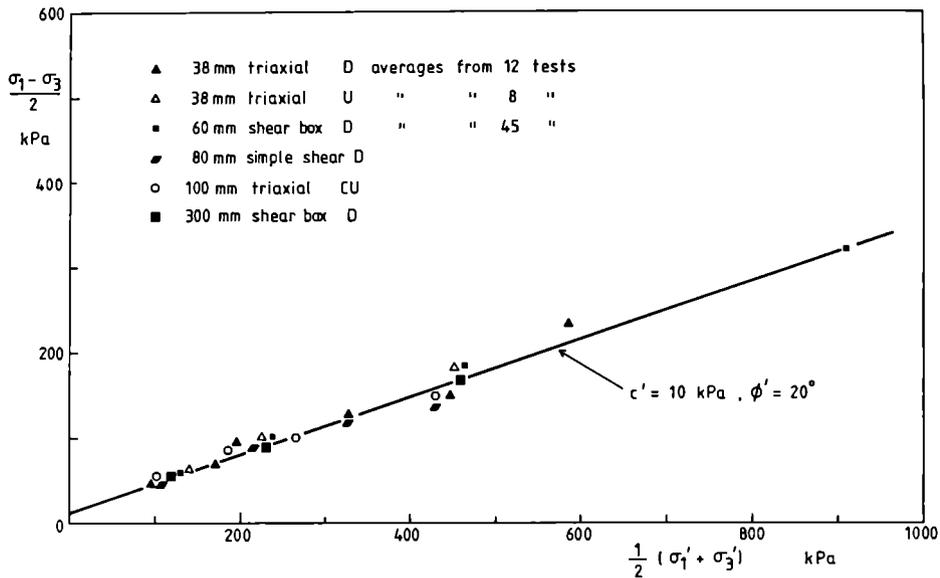
Fig. 7 Yellow Clay Shear strength (peak, intact)

the results (Fig. 7) being practically independent of sample size or type of test.

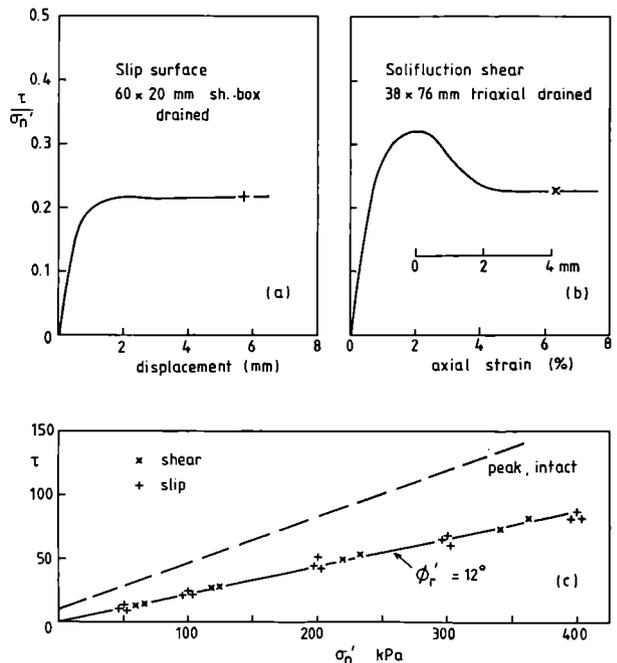
Fig. 8 Yellow Clay Strength on solifluction shears and slip surfaces

Residual strength was determined by shear box tests on slip surface samples, with the polished and striated slip surface placed exactly in the separation plane of the box. Fig. 8(a) shows a typical stress-displacement curve and the results of all these (fifteen) tests, plotted in Fig. 8(c), give

$$c'_r = 0 \quad \text{and} \quad \phi'_r = 12^\circ$$

Triaxial tests on samples taken diagonally across a solifluction shear, so that failure in the test occurs along the shear, show a small peak followed by a drop to residual after not more than 4 or 5 mm, see Fig. 8(b). Up to peak the displacements are strain controlled and the stress-strain curve is almost identical to that of intact clay. The drop from peak to residual, by contrast, is entirely a function of post-peak displacement as the shear is pre-existing. The stress-displacement curve for a 1 m thick layer of clay containing a (horizontal) pre-existing shear surface is therefore as shown by line (b) in Fig. 11.

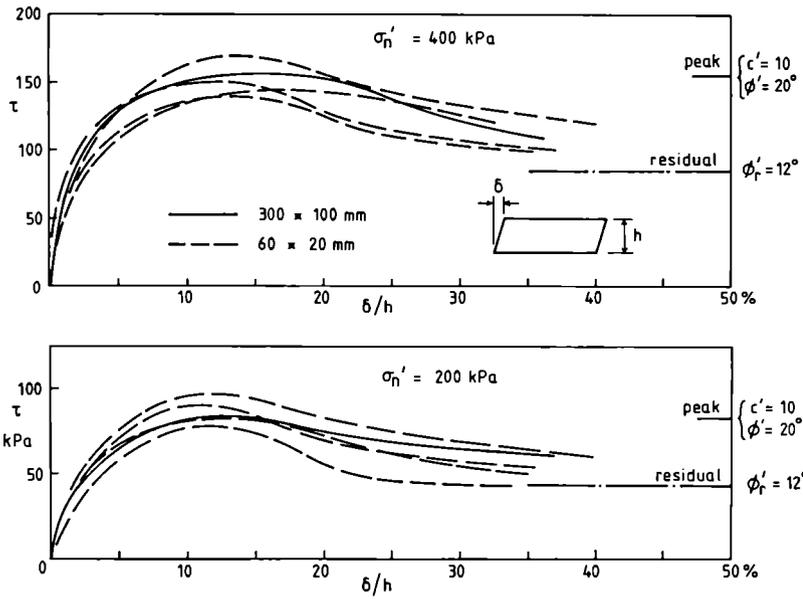
Fig. 9 Yellow Clay, Shear box tests (drained)

Stress-strain curves for samples 20 mm and 100 mm thick, tested in 60 mm and 300 mm shear boxes respectively, show little scale effect up to strains of 30 percent, see Fig. 9, and it is interesting to note the way in which the strength parameters decrease with increasing post-peak strains, see Fig. 10. However, horizontal 'displacement shears' would probably have been developing by the end of the test and thereafter strength might be expected to decline to the residual more in accordance with absolute displacement than with shear strain. From ring shear tests on clays the additional displacement, after 30 percent shear strain, to produce residual strength is typically of the order 200 mm. Thus for a layer 1 m thick the stress-displacement curve for intact clay will be approximately as shown by line (a) in Fig. 11.

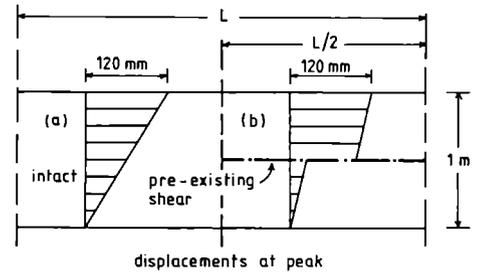
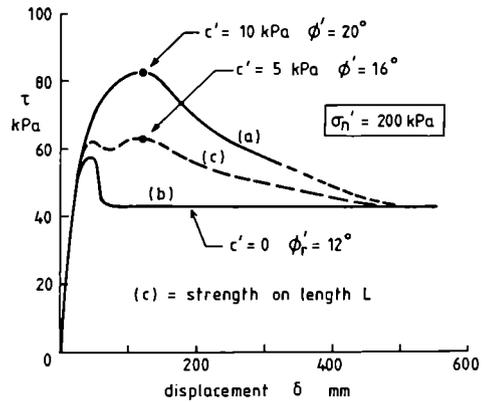
Fig. 11 Stress - displacement curves for a clay layer with a pre-existing shear

The resultant stress-displacement curve for a layer containing any given proportion of sheared to intact clay, all subject to the same displacement, can now be drawn. For a proportion of 50 percent, as at Carsington, the curve is line (c) in Fig. 11.

In reality a minor correction is required to allow for the fact that the shears are undulating, not plane. This can be taken into account by increasing the 'effective' residual, as measured in a horizontal direction, to  $(\phi_r + 1)$  and it is reasonable to assume  $i = 2^\circ$ . Thus when the intact clay reaches peak the strength in the sheared clay will be represented by  $\phi' = 14^\circ$ . At larger displacements the 'horizontal' strength of the sheared clay, as also in the intact clay, must fall to the residual.

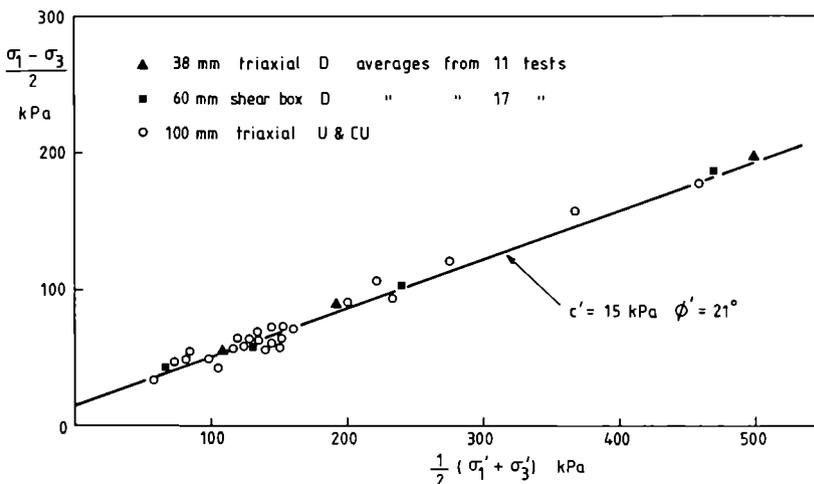
Fig. 12 Core Shear strength (peak, intact)

are plotted in Fig. 12. They give

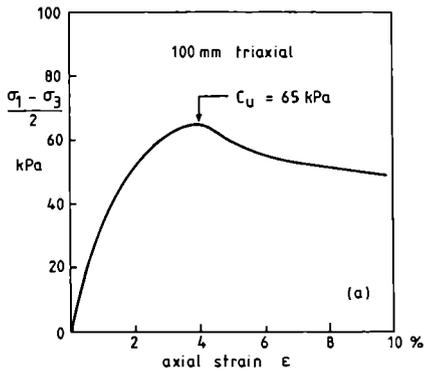
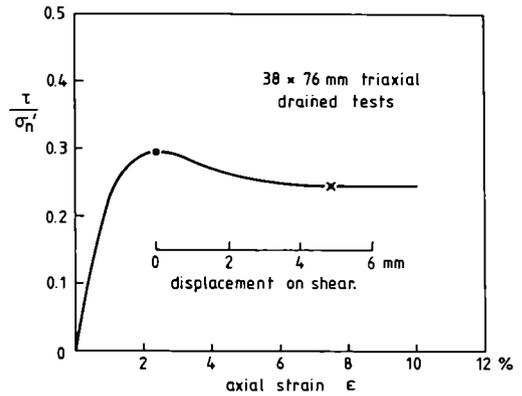
Fig. 13 Core. Undrained tests on intact material

In undrained triaxial tests the peak is reached at about 4 percent axial strain, Fig. 13(a). At 6 percent strain the strength falls 15 percent below peak and the corresponding effective stress parameters, Fig. 13(b), are

At the 'critical state' condition, with  $c' = 0$  and  $\phi' = 21^\circ$ , there is a reduction of approximately 20 percent in undrained strength below the peak and this is reached at about 8 percent axial strain.

The 'critical state' parameters for intact core material ( $c' = 0$  and  $\phi' = 21^\circ$ ) correspond to a vertical compression around 8 percent. A better figure, just prior to failure, is 6 percent and this leads to  $c' = 5$  kPa and  $\phi' = 21^\circ$ : see Fig. 13(b). Taking  $\phi'_s = 16^\circ$  on the rutting shears the bulk strength parameters become  $\bar{c}' = 2$  kPa and  $\bar{\phi}' = 19.5^\circ$ , leading to an increase of about 5 percent in factor of safety. This also implies a larger degree of progressive failure in the Yellow Clay in order to give  $F = 1.0$  at failure, corresponding to  $\phi' = 15.4^\circ$  (with  $c' = 0$ ) and a residual factor  $R = 0.45$  instead of 0.4.

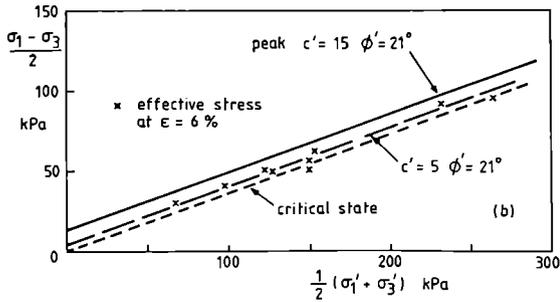
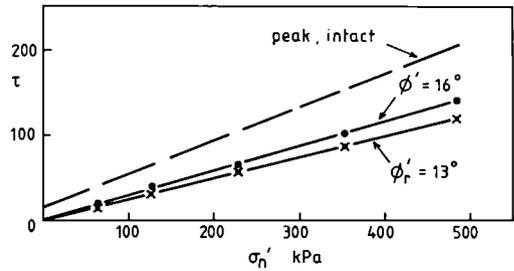
Fig. 14 Core. Strength on rutting shears

Triaxial tests on samples taken diagonally across rutting shears in the core, so that failure occurs on the shear, show (Fig. 14) 'peak' parameters  $c' = 0$  and  $\phi' = 16^\circ$  and a residual strength of  $c' = 0$  and  $\phi'_r = 13^\circ$ .
